Innovative Options for Flexible Pipeline & Caisson Repair

Stewart Duthie
Flexlife Ltd.

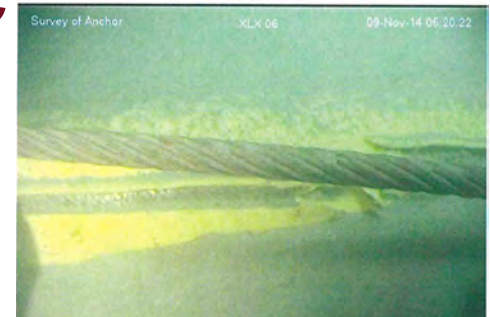
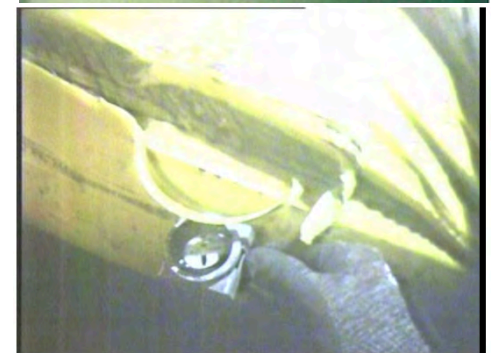
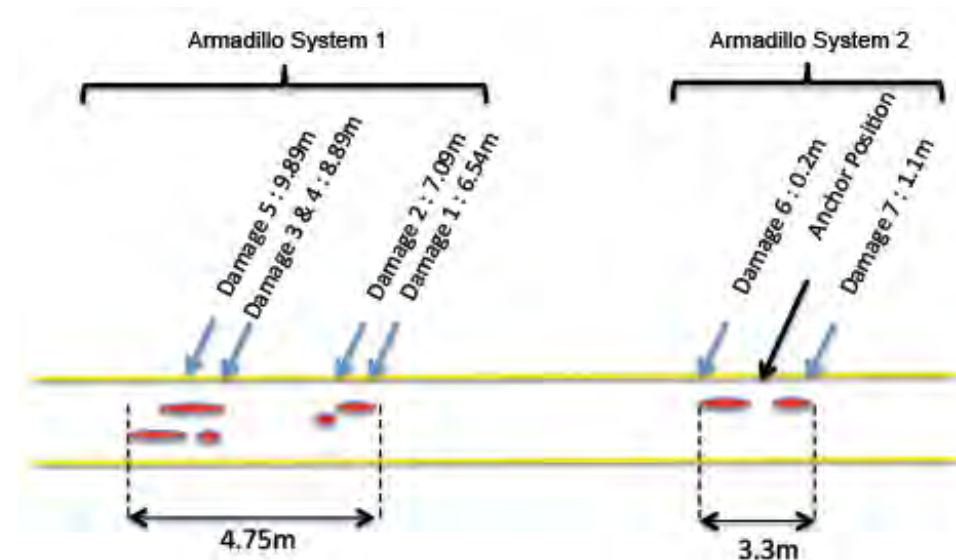
- 12" Production Flowline
- GE Oil & Gas manufacture
- Traditional rough bore static design with HDPE outer sheath
- Flowline outer diameter 359mm
- 3.3 km long, laid in 64m water depth
- Post install dropped object (anchor) damage
- Multiple perforations of flowline outer sheath
- Annulus metallic layers exposed
- Manufacturers recommendation that the outer sheath be repaired.
- Option to recover to deck, repair and re-lay
 - Higher risk, higher cost.
- Or, repair in-situ
 - Lower risk, lower cost

- Modular design of Armadillo® facilitates the repair to long areas of outer sheath damage
- Flowline lifted using subsea A-frame
- Diver installed, segment by segment over damage location
- Post-install, flowline has one end lowered to seabed
- FlexGel-A™ is then filled from highest point
- Controlled from topsides by Flexlife engineers
- FlexGel-A™ is lighter than seawater
- Displaces seawater within the Armadillo annulus
- Re seals the flowline outer sheath

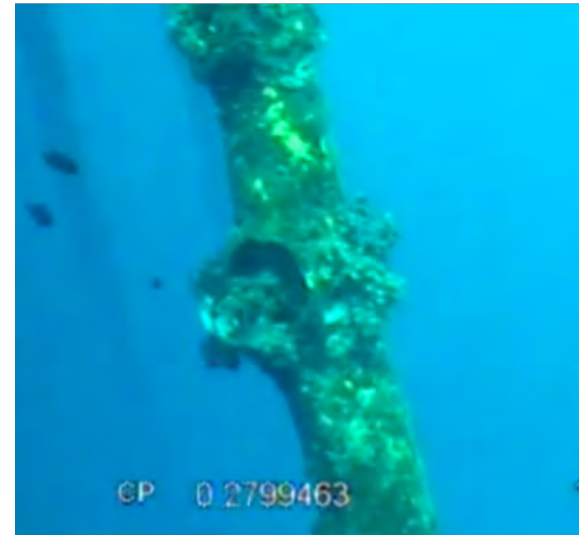
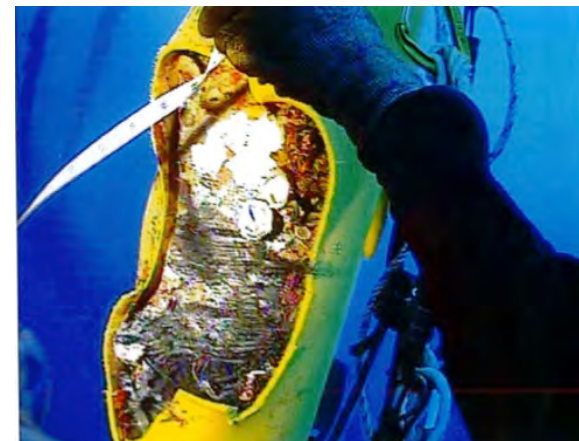
- Turret moored FPSO operating in 60m water depth, SE Asia
- ROV fly-by highlighted serious outer sheath damage on riser
- Located 1m below bend stiffener location
- Suspected to have been caused by vent port blockage
 - Leading to annulus overpressurisation
 - Subsequently to outer sheath rupture
 - Metallic tensile and pressure wires exposed to seawater
 - Risk of general corrosion
 - Risk of corrosion fatigue

- Armadillo® is designed to accommodate small discrepancies in riser o/d
- Constructed from polymer, typically HDPU
- Failure root cause, in this instance, was sheath over-pressurisation caused by marine growth induced vent port blockage
- Post install on the riser, additional venting system was installed through Armadillo® repair clamp
- Armadillo® annulus was then injected with FlexGel-A™ to provide an isolation between the seawater and the riser annulus
- Riser End-Fitting Pressure Relief Valves were also replaced
- This exercise allowed residual pressure to be released on two adjacent risers, BEFORE the outer sheaths ruptured

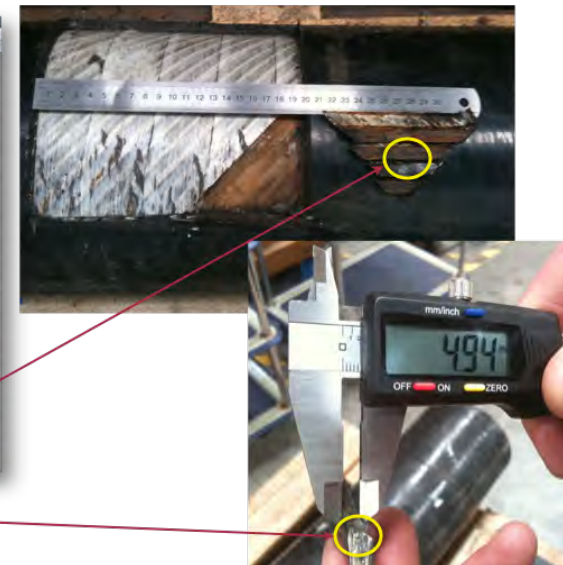
Scanned then measured armour wires

- Detailed inspection data
- Decision to use ROV deployed ultrasonic inspection
- Patented FlexScan™ technology
- Using Neptune UT scanner
- UT offers clear information regarding transitions between and through materials
- The speed of sound through a known material enables accurate thickness measurement
- Used to reduce conservatism in life extension study
 - Global dynamic analysis
 - Local fatigue analysis

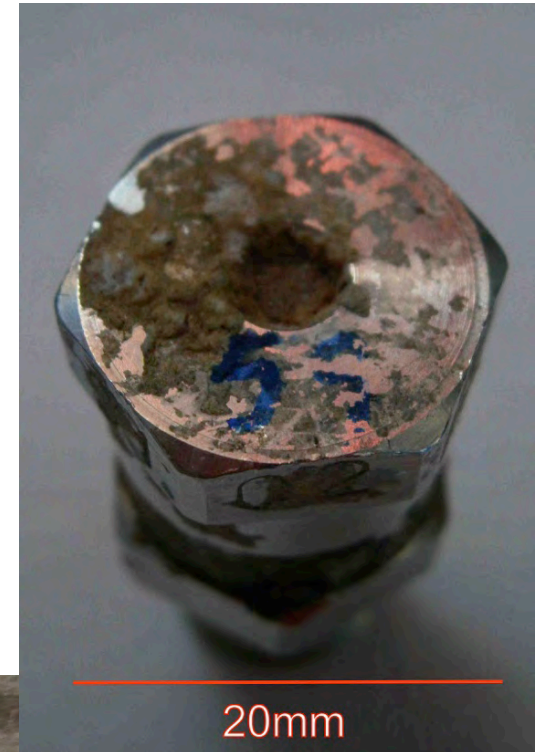
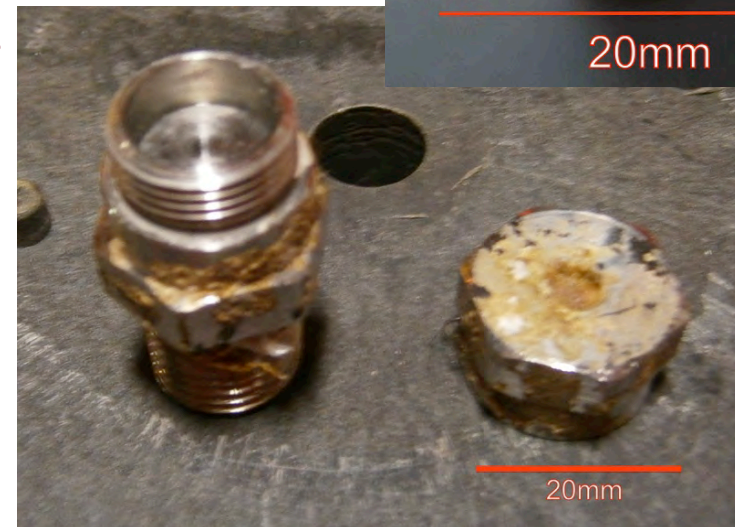
- Lessons learned
- Tolerance fit is essential to repair a deformed outer sheath
 - Ovality was in excess of 20%
- Metrology is especially complex where a riser has been subject to overpressurisation
 - Once damaged sheath had been stripped back, damage length was 50% greater than anticipated
- The build up of marine growth requires careful maintenance, particularly on risers with subsea end-fittings.
- Routine removal of marine growth, particularly around Pressure Relief Valves (PRV) is essential.

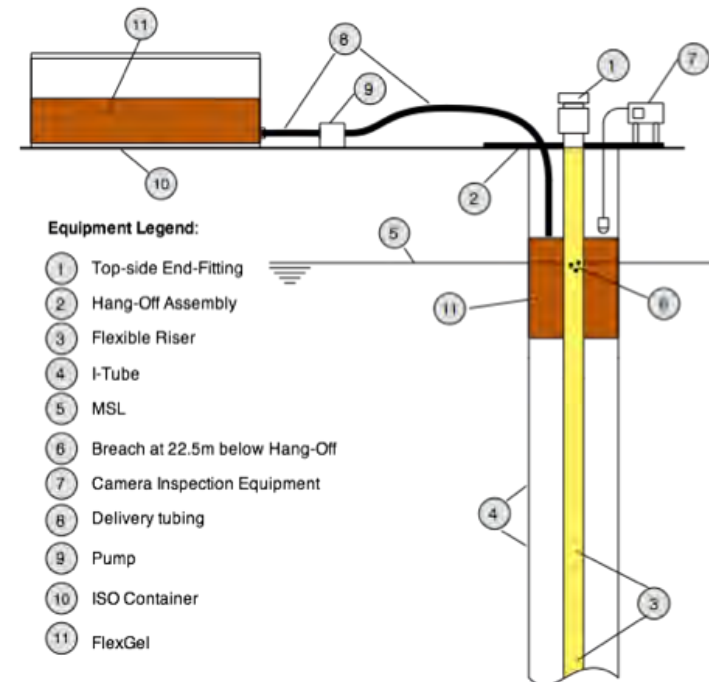
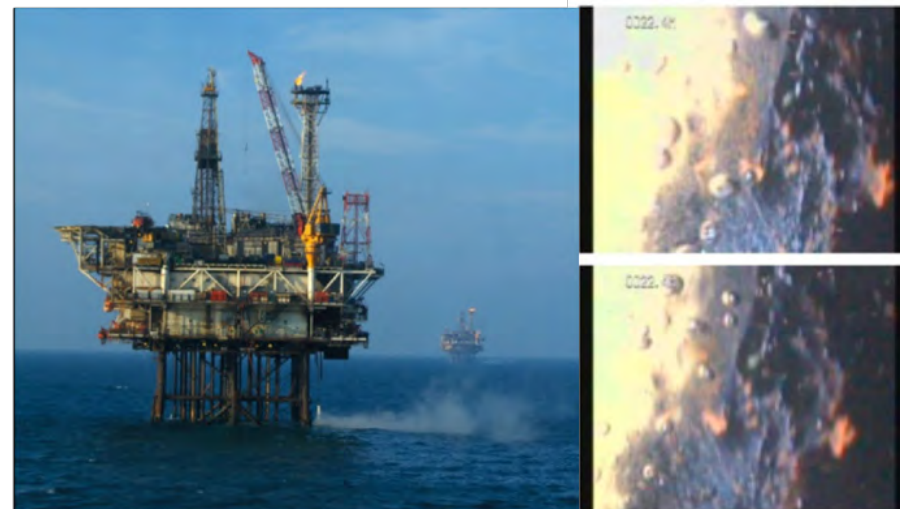
- Riser positive pressure annulus testing indicates a loss of outer sheath integrity at 13m below MSL
- Confirmed by CVI
- Inaccessible location
- No apparent marketplace solution
- FlexGel® developed to address corrosion concerns
 - Tuned SG
 - Tuned viscosity
 - Immiscible
 - Thixotropic
 - Non flammable
 - Replaces seawater with benign gel
 - Environmentally approved by CEFAS, OCNS
 - Mitigates splash zone corrosion

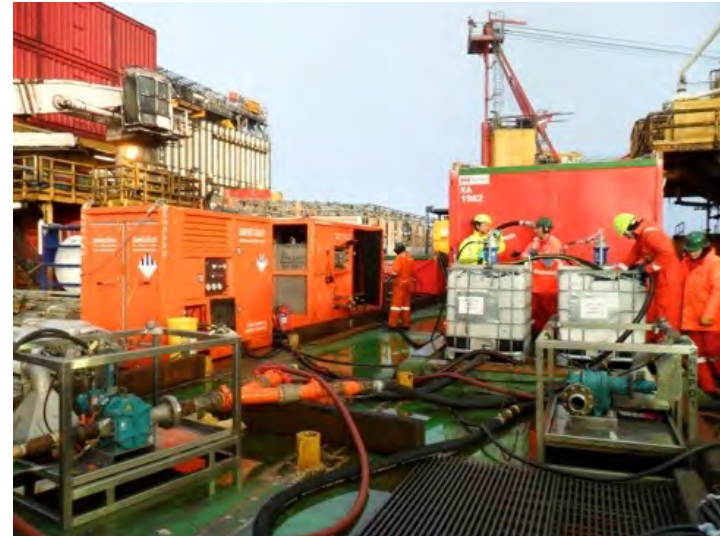
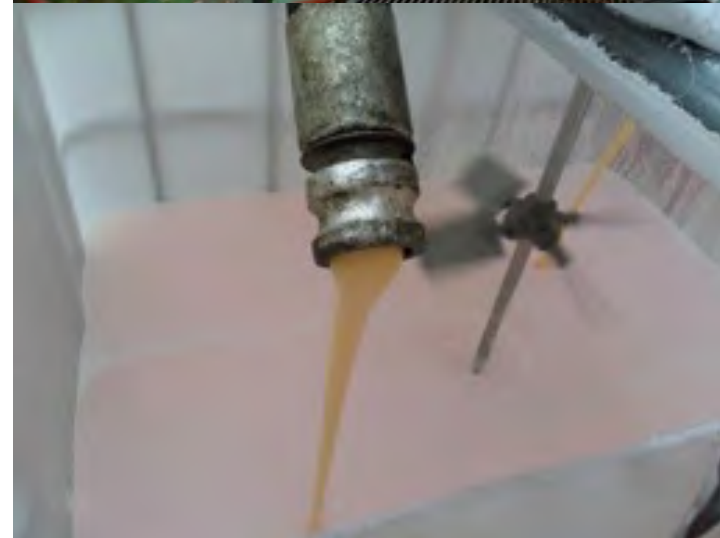
- UIC occurs in stuffing gland between in gas tight floor of CONDEEP platform leg
- Leads to leak in rundownline
- Inaccessible location
- Production shut-in from platform and linked fields
- No apparent marketplace solution
- FlexGel-PS™ developed to seal leak
 - Tuned SG
 - Injected as liquid
 - Tuned cure time
 - Replaces bore fluid becoming an elastic solid
 - Seals leak location internally
 - Enabling permanent external repair to be facilitated
 - Can be chemically 'broken' into component liquids
