Innovative Options for Flexible Pipeline & Caisson Repair

Stewart Duthie
Flexlife Ltd.

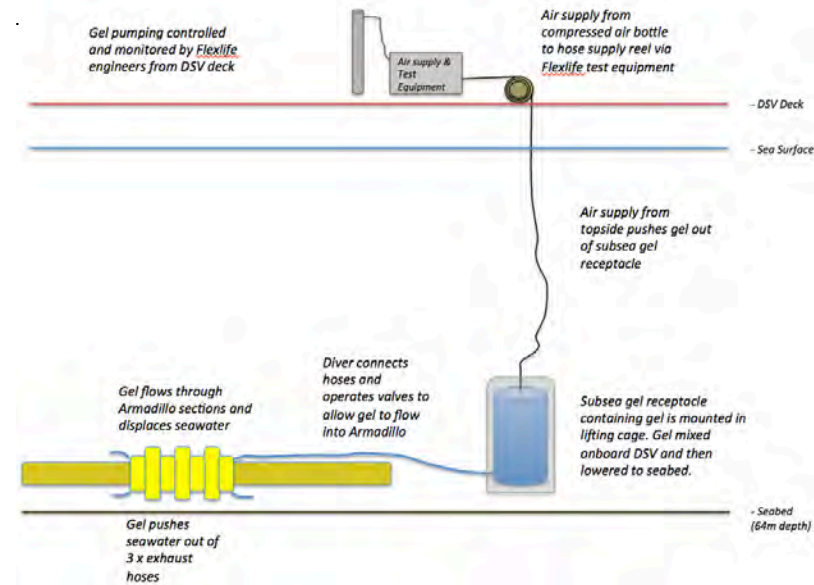
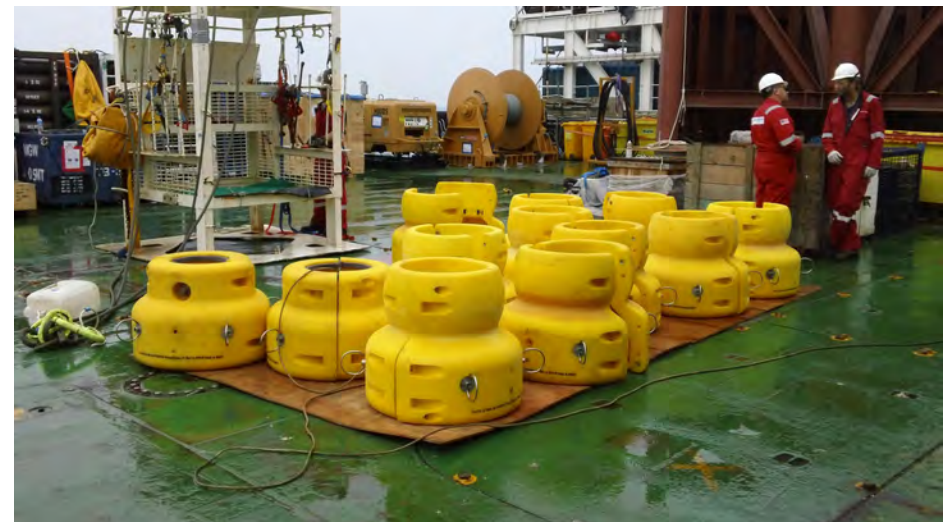
- Modular design of Armadillo® facilitates the repair to long areas of outer sheath damage
- Flowline lifted using subsea A-frame
- Diver installed, segment by segment over damage location
- Post-install, flowline has one end lowered to seabed
- FlexGel-A™ is then filled from highest point
- Controlled from topsides by Flexlife engineers
- FlexGel-A™ is lighter than seawater
- Displaces seawater within the Armadillo annulus
- Re seals the flowline outer sheath

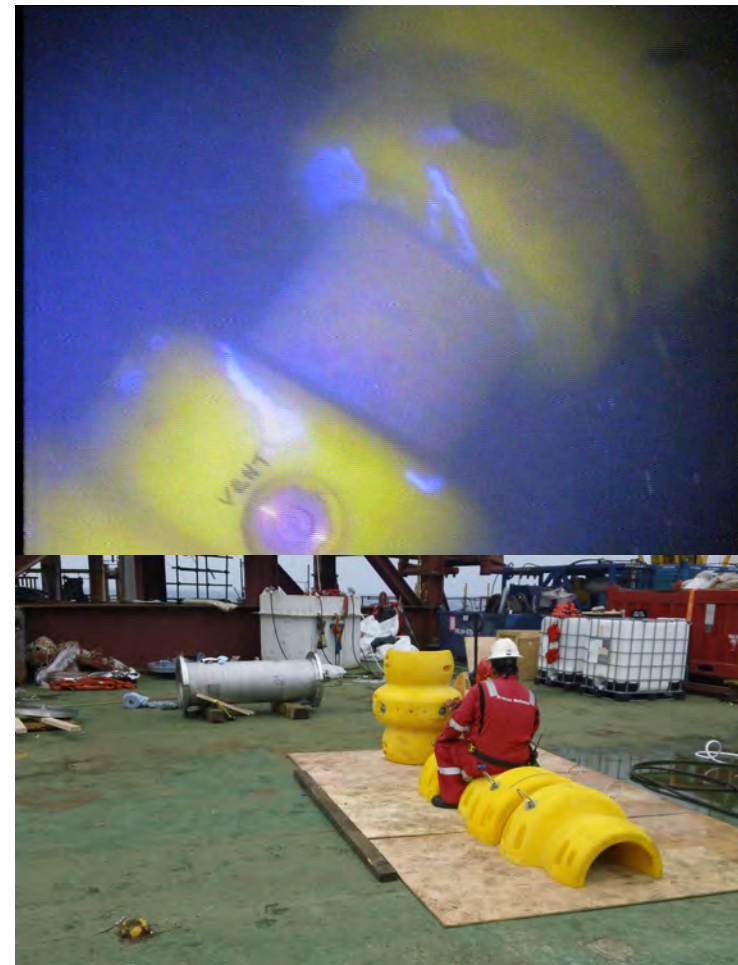
- Lessons learned
- Prudent to carry additional segments.
- Original damage length was indicated to span 8.25m
- On installation, spare segments were used to cover 10.3m
- Once FlexGel-A™ is activated, vessel SIMOPS should be avoided

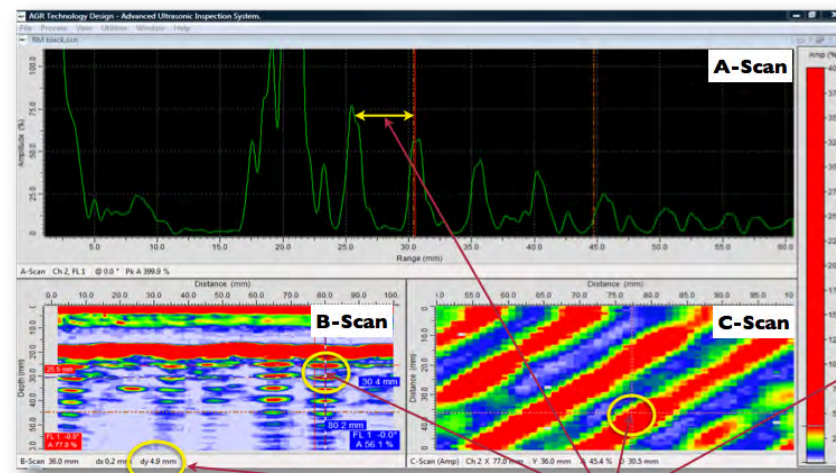
Scanned then measured armour wires

- Detailed inspection data
- Decision to use ROV deployed ultrasonic inspection
- Patented FlexScan™ technology
- Using Neptune UT scanner
- UT offers clear information regarding transitions between and through materials
- The speed of sound through a known material enables accurate thickness measurement
- Used to reduce conservatism in life extension study
 - Global dynamic analysis
 - Local fatigue analysis

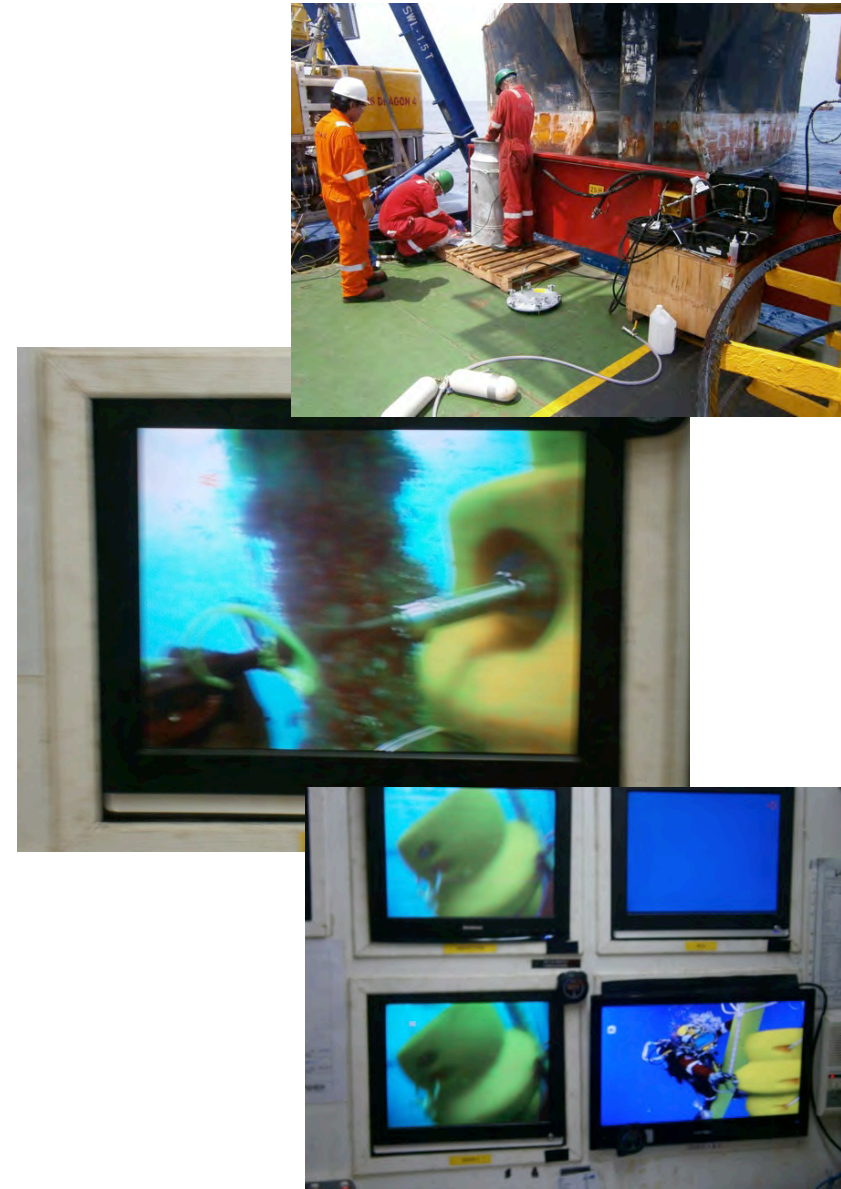
- Armadillo® is designed to accommodate small discrepancies in riser o/d
- Constructed from polymer, typically HDPU
- Failure root cause, in this instance, was sheath over-pressurisation caused by marine growth induced vent port blockage
- Post install on the riser, additional venting system was installed through Armadillo® repair clamp
- Armadillo® annulus was then injected with FlexGel-A™ to provide an isolation between the seawater and the riser annulus
- Riser End-Fitting Pressure Relief Valves were also replaced
- This exercise allowed residual pressure to be released on two adjacent risers, BEFORE the outer sheaths ruptured

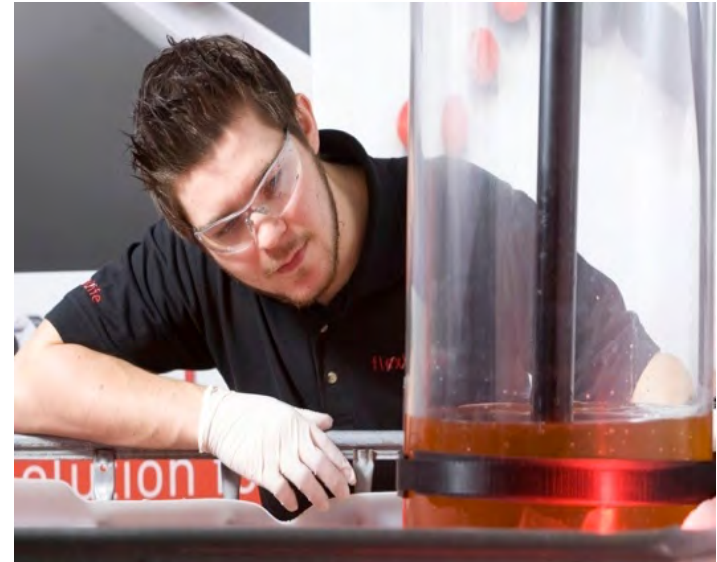
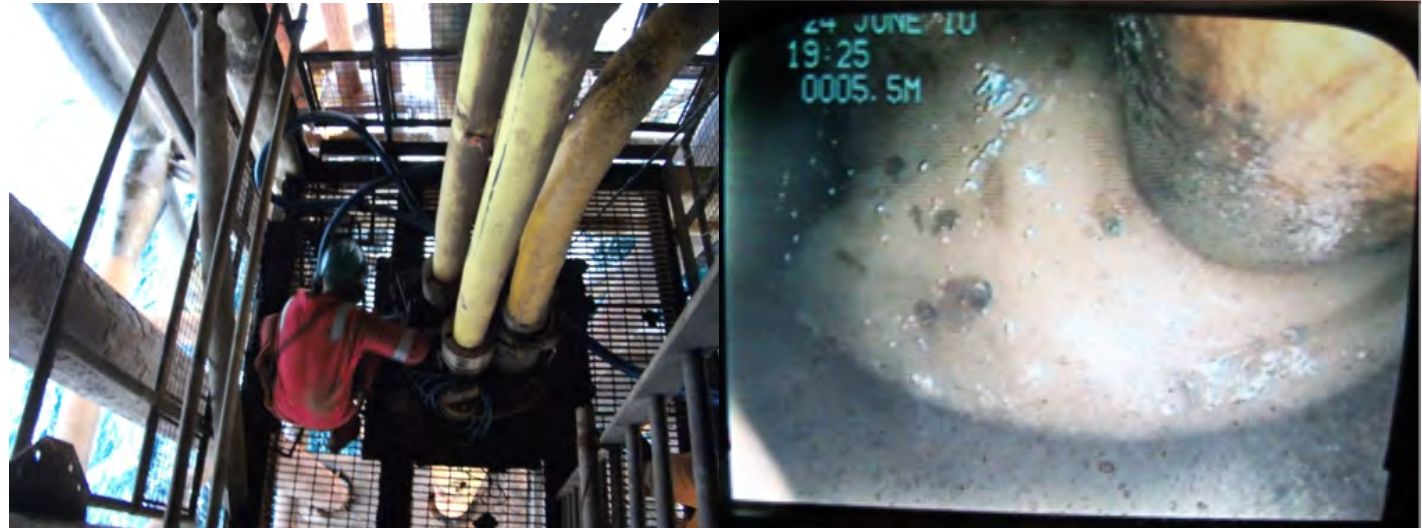
- Lessons Learned
- Coupon samples should be collected at install to allow ongoing chemical monitoring of gel
- Inspection of gel level within I-tube should be regularly monitored and referenced with tidal state
- Compatibility testing may be required pre-install, e.g. neoprene coatings, high temperatures, etc.

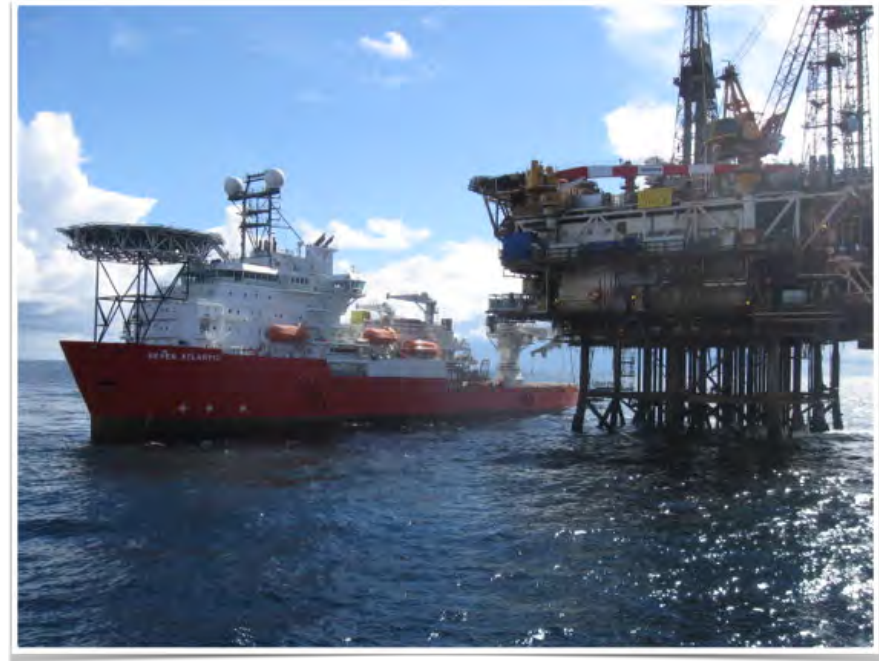
- Lessons Learned
- Coupon samples should be collected at install to allow chemical monitoring of polymer plug
- Chemical breaking of FlexGel-PS™ requires an oxidising agent
- Volume injected should be engineered to the minimum required to achieve objective in order to simplify the, post repair, removal process

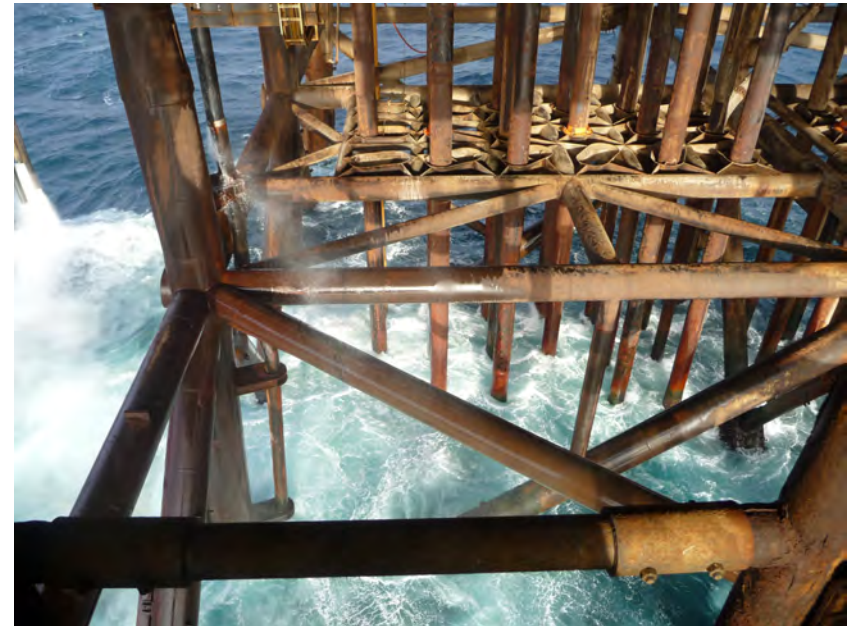
- During operational life, leaking J-tube seals can lead to issues with corrosion within caissons, I-tubes, J-tubes
- Dosing regime compromised by seawater leaching/dilution
- If unchecked can, and has, resulted in riser failures
- Current developments
- Adapt FlexGel-PS™ by tuning SG heavier than seawater
 - Inject through J-tube to form a heavier than seawater elastic plug
 - Reinstate J-tube seal
 - Reinstate design dosing regime
 - Adapt inspection frequency and continue to operate
